1. REPORT DATE (DD-MM-YYYY) 25-1-2013		2. REPORT TYPE Performance/Technical Report (Monthly)		3. DATES COVERED (From - To) 12/26/12 - 1/25/13	
4. TITLE AND SUBTITLE  Polyfibroblast: A Self-Healing and Galvanic Protection Additive				5a. CONTRACT NUMBER	
				5b. GRANT NUMBER  N00014-09-1-0383	
				5c. PROGRAM ELEMENT NUMBER

# **POLYFIBROBLAST: A SELF-HEALING AND GALVANIC PROTECTION ADDITIVE**

## ***Progress Report #14***

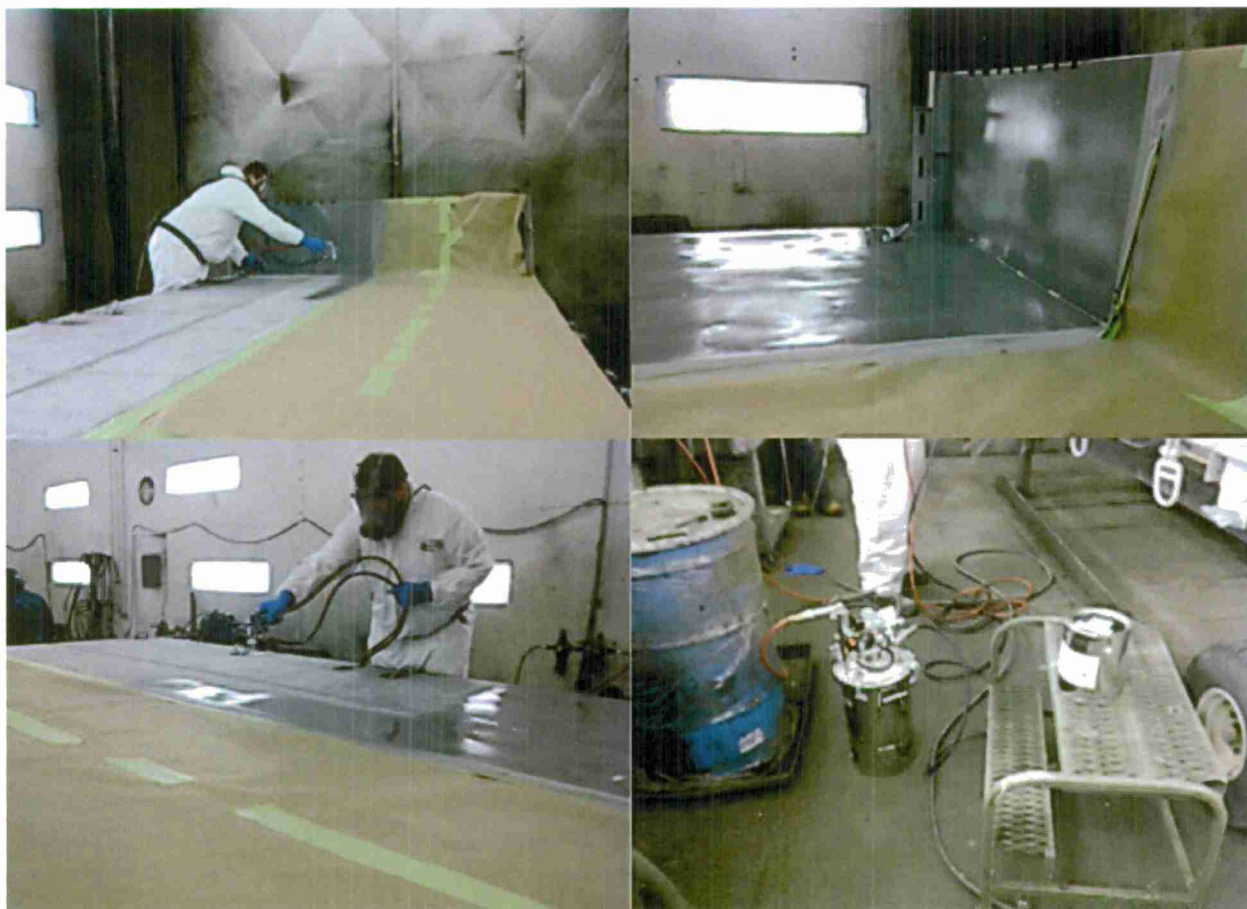
**Figure 1:** Application of the Polyfibroblast primer in the temperature controlled spray booth on January 15, 2013.

Figure 1 shows the application of the Polyfibroblast primer to the left half of the truck bed. The front, top, sides, and underbody were all covered with primer. During application, we observed almost no spurting of the paint, which would have indicated the presence of microcapsule aggregates. PPG has therefore done an excellent job improving the dispersion of the microcapsules into the MIL-P-26915 primer. The dry film build ranged from 7 to 17 mils depending on the location. Due to a shift change, the painting process took slightly longer than expected. The whole process took approximately 4 hours.

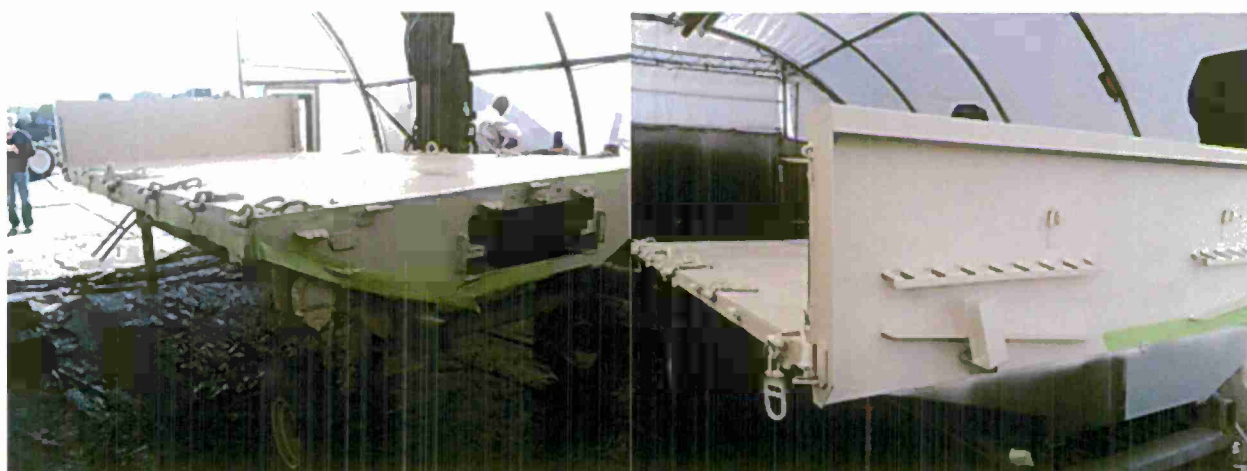
**Figure 2:** Both the self-healing primer (left side of truck bed) and the unmodified zinc-rich primer (right half of truck bed) were overcoated with a layer of MIL-DTL-53022 CARC primer. Afterwards, the bottom of the truck was painted with a black undercoat.

Following the application of the topcoat, the painters from the CRF applied a layer of MIL-DTL-53022 CARC primer (Fig. 2). The CARC primer was applied approximately four hours

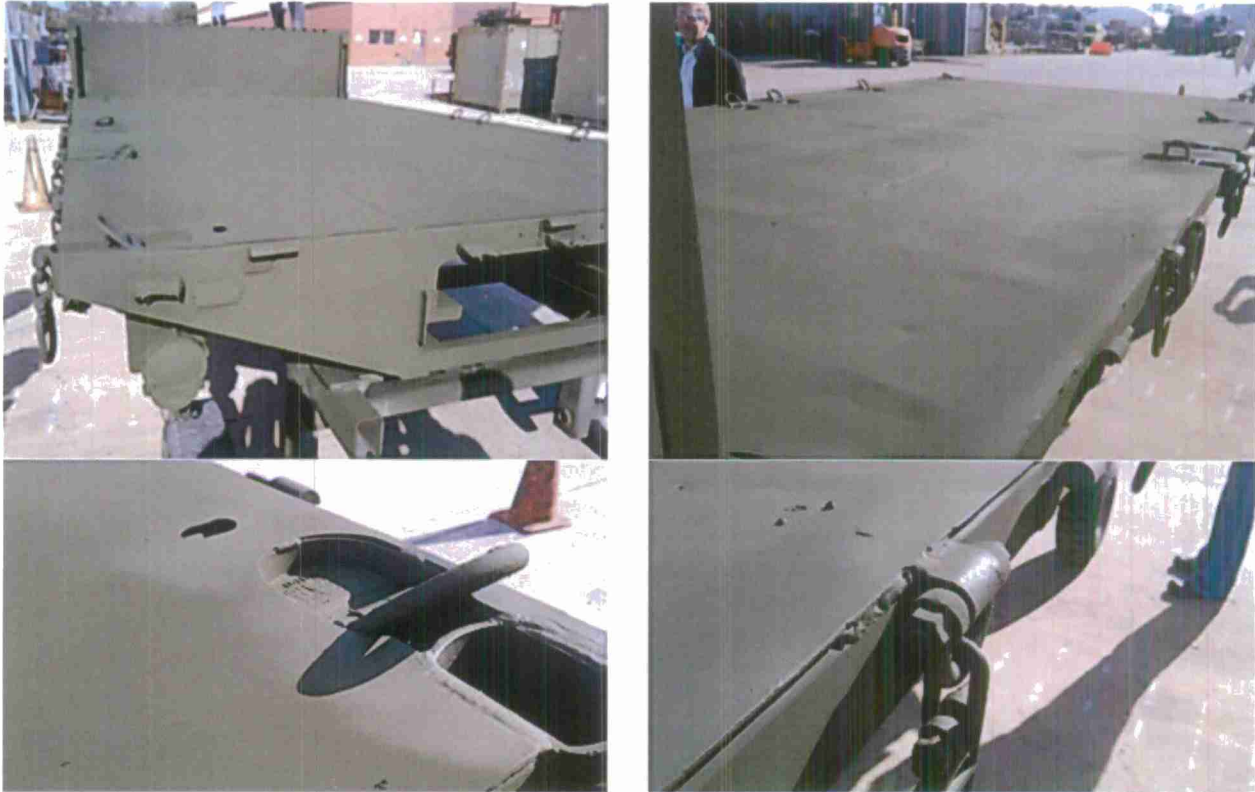
**Figure 3:** The final coating was a layer of MIL-DTL-64159 CARC topcoat, which was applied using an electrostatic spray process.

after the Polyfibroblast primer was applied. Finally, the MIL-DTL-64159 CARC topcoat was applied using an electrocoat process (Fig. 3).
